White Paper: Rev. 1, November 2011

Eliminating Sub-floor Nail Squeaks in Residential Construction

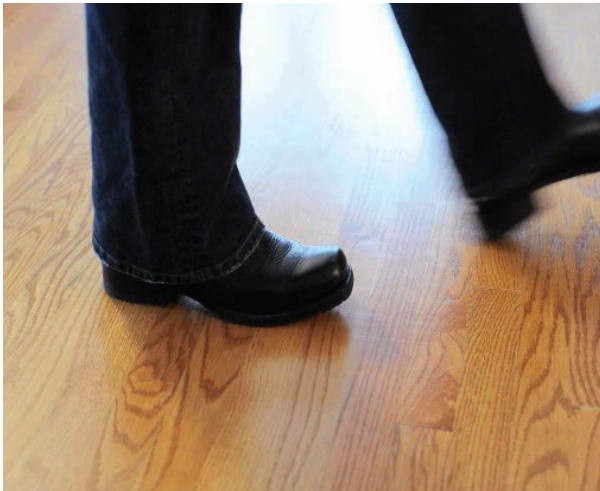
Figure 1. Sub-floor squeaks are a major percentage of customer complaints and callbacks in new residential construction.

Sub-floor squeaks are a major problem in home builders' line of work. A major reason for complaints from new homeowners, these defects are the top cause of callbacks in new homes for many production home builders.

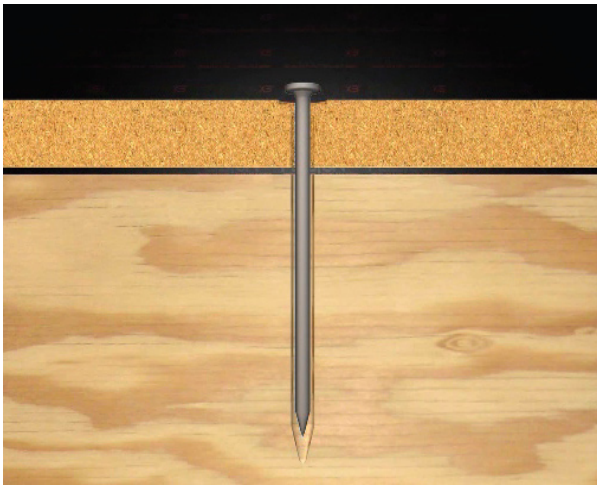
Figure 2. When first installed, moist sub-floors swell and push the nail up, then fail to tighten around the loosened nail when HVAC systems are turned on at move-in, causing sub-floor squeaks.

anchor the sub-floor to the joists. The sound of the squeak is the smooth shank of the nail rubbing against the sub-floor panel, which is usually constructed of OSB or plywood. For several possible reasons, the nail becomes loose and rubs against the sub-floor as weight is applied to the floor. The primary reason is the change in moisture content of the lumber from installation to homeowner occupancy. Sub-floor panels often remain at least partially exposed to the elements at construction sites for days or even weeks after their installation. During this period, the panels become moist, either from rain or simply by absorbing moisture from the air. This moisture causes the panels to swell, pushing the nail out of its tight position. Later, when construction is completed and the home is occupied, air conditioning and heating systems dry out the air in the home and dry out the subfloor. In the sub-floor, wood fibers do not solidify around the nail, but instead further retract, which decreases holding power. With the nail now loosened, weight on the floor causes the sub-floor to rub against the loosened nail, causing an audible squeak.

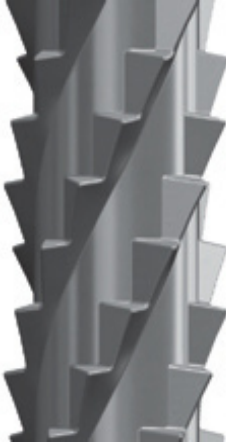
Figure 3. The barbed helix geometry of the Paslode TetraGrip fastener bonds with the lumber to increase holding power.

Paslode® has developed a fastening system – an alternative to traditional nails and screws – that eliminates sub-floor nail-induced squeaks. This TetraGRIP™ fastener uses a barbed-helix geometry (see Figure 3) all the way to the head in its shank design. Because the fastener has no smooth surface, it cannot squeak.

This patent-pending design ensures that the fastener rotates into the floor boards and floor joists smoothly as it is driven and does not destroy the lumber. The threads and barbs bond with the lumber to provide superior holding power. By comparison, traditional ring-shank nails bore a hole through the lumber when they are driven, but do not bond effectively with the lumber.

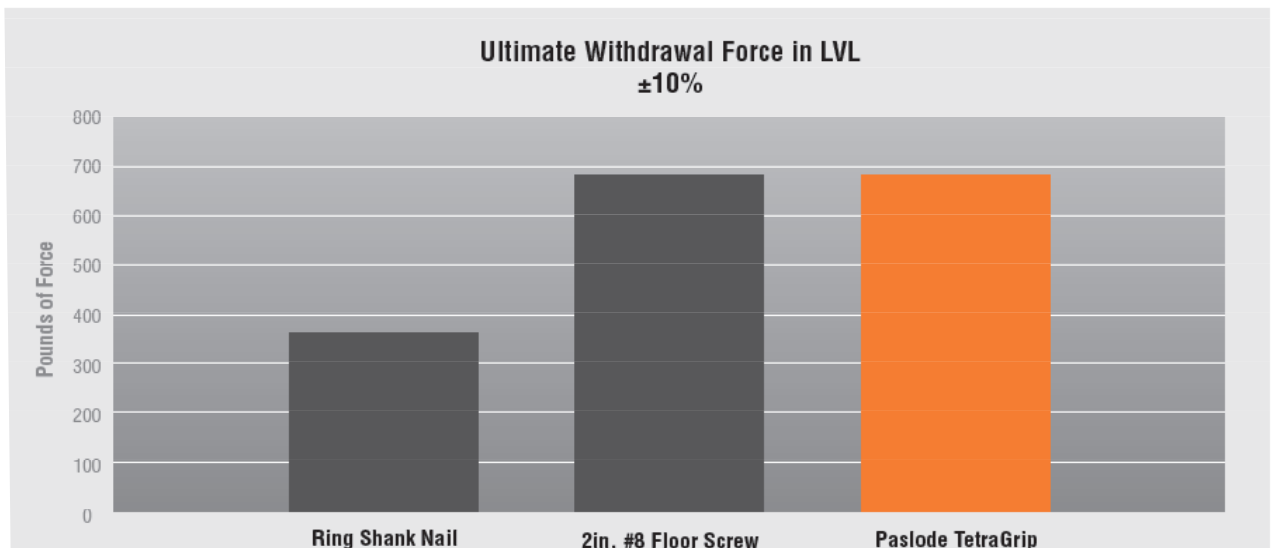
Figure 4. Internal testing of the Paslode sub-floor fastener in laminated veneer lumber (LVL) shows its superior holding power compared to a ring shank nail, and comparable holding power to a floor screw.

The fastener's unique barbed helix-to-wood engagement creates high holding power that rivals that of a floor screw (see Figure 4).

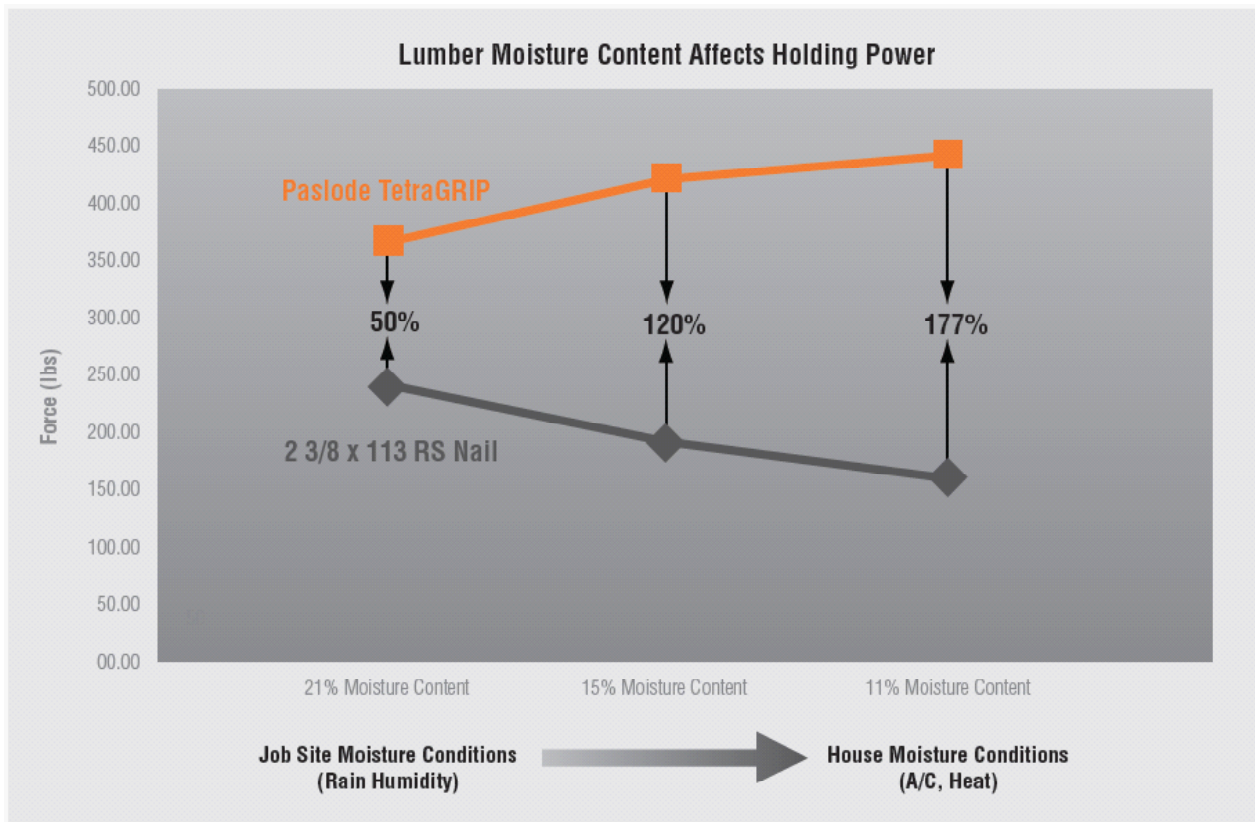
Figure 5. Internal testing confirms that the Paslode TetraGRIP fastener increases its holding power as moisture content decreases (like a screw, but unlike a nail).

While the holding power of a nail decreases as the moisture content decreases (i.e., as the lumber is dried by the home's HVAC system), the holding power of the Paslode TetraGRIP fastener increases as moisture content decreases. In this way, the Paslode fastener behaves like a screw (see Figure 5).
